# Manhole Inspection Summary

Manhole # S49Y1\_005MH

Insp Date: **5/27/08 10:50 AM**

**Location** Address: **1440 Chesapeake Ave.**

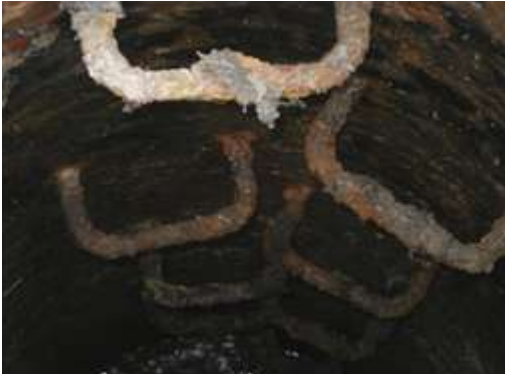
Steps

Count: **8** Missing: **0** ☒ **Corroded**

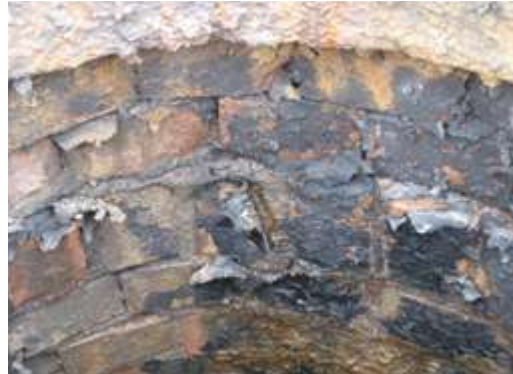
Defect 2

Infiltration: ☐ None ☒ **Joint** ☒ **Cracks** ☐ Mortar ☐ Roots ☐ Wall

Infiltration

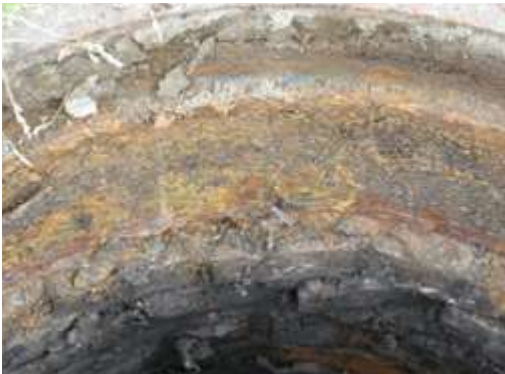
Defect 1

Offset: **0.5** (in.)

Frame Offset

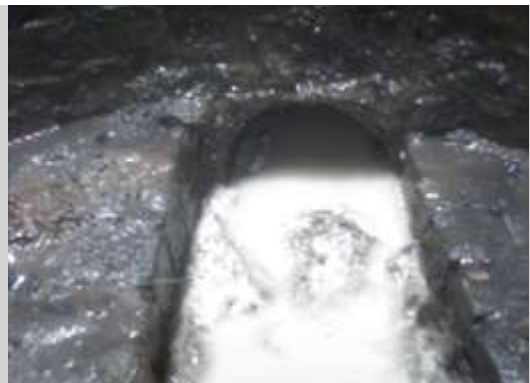
12 O'Clock Outflow

Pipe Height: **8.4** (in.) Rod and Bar (Angled)  
Pipe Material: **Clay** ☐ Pipe Lined  
Invert Depth: **15.00** (ft.) Flow Characteristics: **Slow**  
Deposits: ☐ None ☐ Mud ☒ **Sludge** ☐ Debris ☐ Grease  
Silt Depth: **3** (in.) Deposits Extent: **Light**  
Infiltration: **None** Pipe Seal Cond: **Unknown**

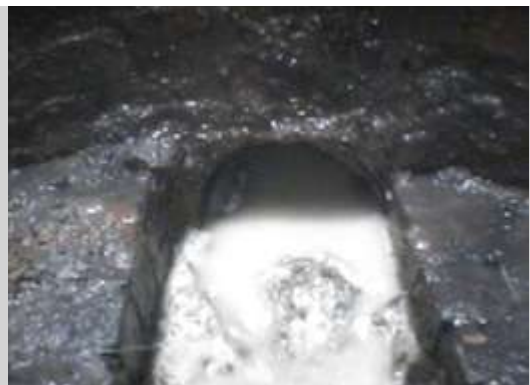
6 O'Clock Inflow

Pipe Height: **8.4** (in.) Rod and Bar (Angled)  
Pipe Material: **Clay** ☐ Pipe Lined  
Invert Depth: **14.94** (ft.) Flow Characteristics: **Slow**  
Deposits: ☐ None ☐ Mud ☒ **Sludge** ☐ Debris ☐ Grease  
Silt Depth: **2** (in.) Deposits Extent: **Light**  
Infiltration: **None** Pipe Seal Cond: **Unknown**
